Traffic Planning Study Town of Wilton

Town of Wilton
22 Traver Road,
Wilton, NY 12831

**VHB Engineering, Surveying, Landscape
Architecture and Geology, P.C.**

December 2024

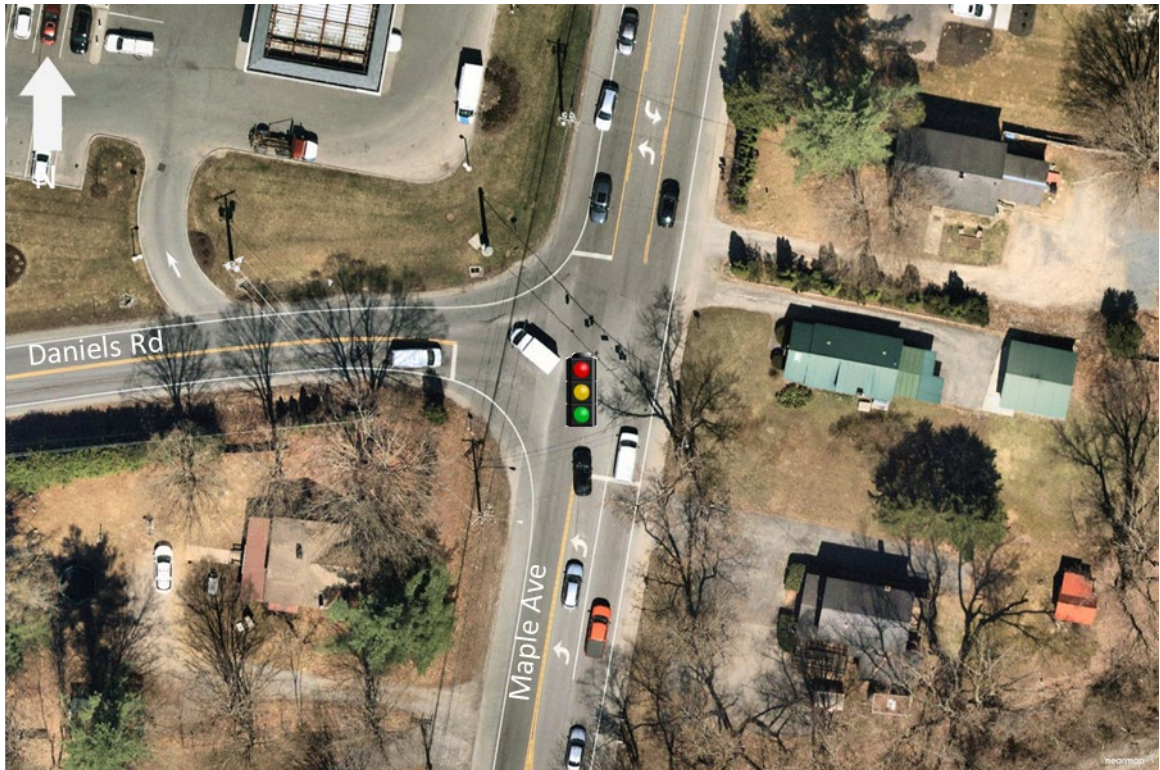
Maple Avenue (US Route 9) at Daniels Road

The Maple Avenue at Daniels Road intersection is a three-leg intersection operating under traffic signal control. The eastbound Daniels Road approach provides a single lane for shared travel movements. The northbound Maple Avenue approach provides a left-turn lane and a through lane. The southbound Maple Avenue approach provides a shared through/right-turn lane. North of Daniels Road there is a center two-way left-turn median extending between the intersection and the Cumberland Farms driveway to the north. There are no sidewalks, marked crosswalks, or pedestrian signals at this intersection.

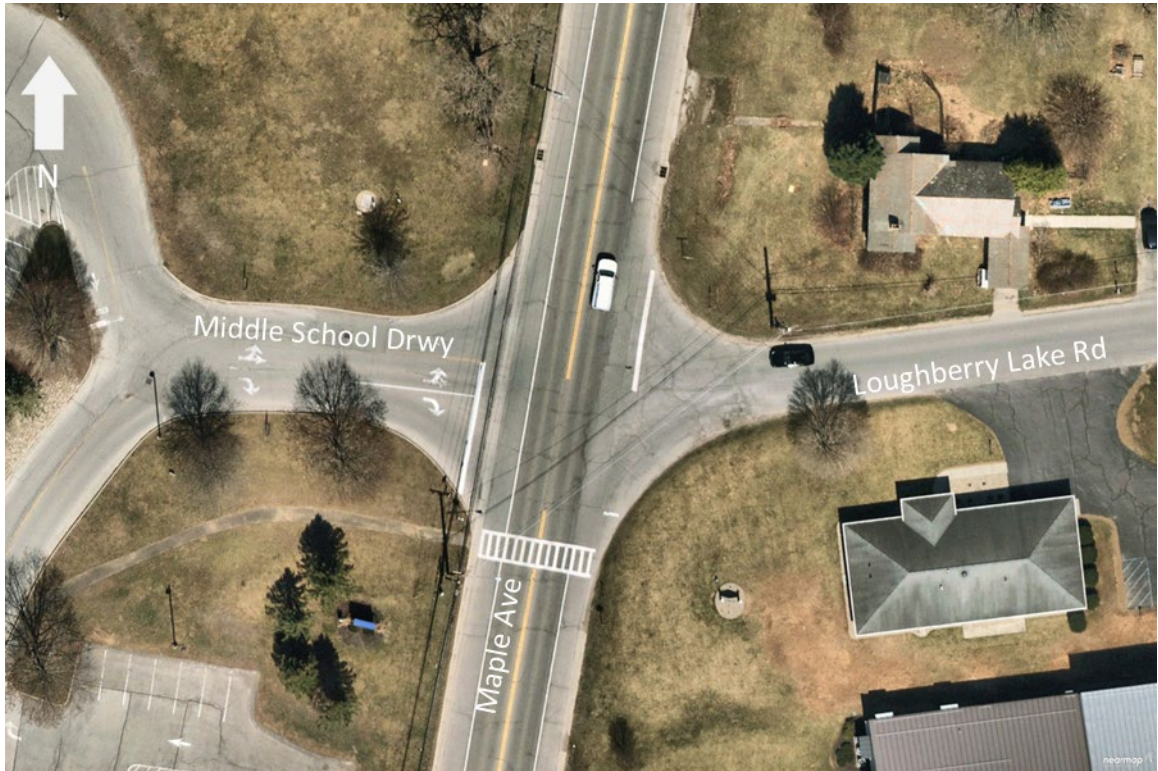
Maple Avenue (US Route 9) at Loughberry Lake Road/Maple Avenue Middle School Driveway

The Maple Avenue at Loughberry Lake Road/Maple Avenue Middle School Driveway (Middle School) intersection is a four-leg intersection operating under stop control on the eastbound Middle School Driveway and westbound Loughberry Lake Road approaches. The eastbound Middle School driveway approach provides a shared left-turn/through lane and a right-turn lane. The other intersection approaches provide a single lane for shared travel movements. A marked crosswalk is provided on the northbound Maple Avenue approach, but no other pedestrian accommodations are provided at this intersection.

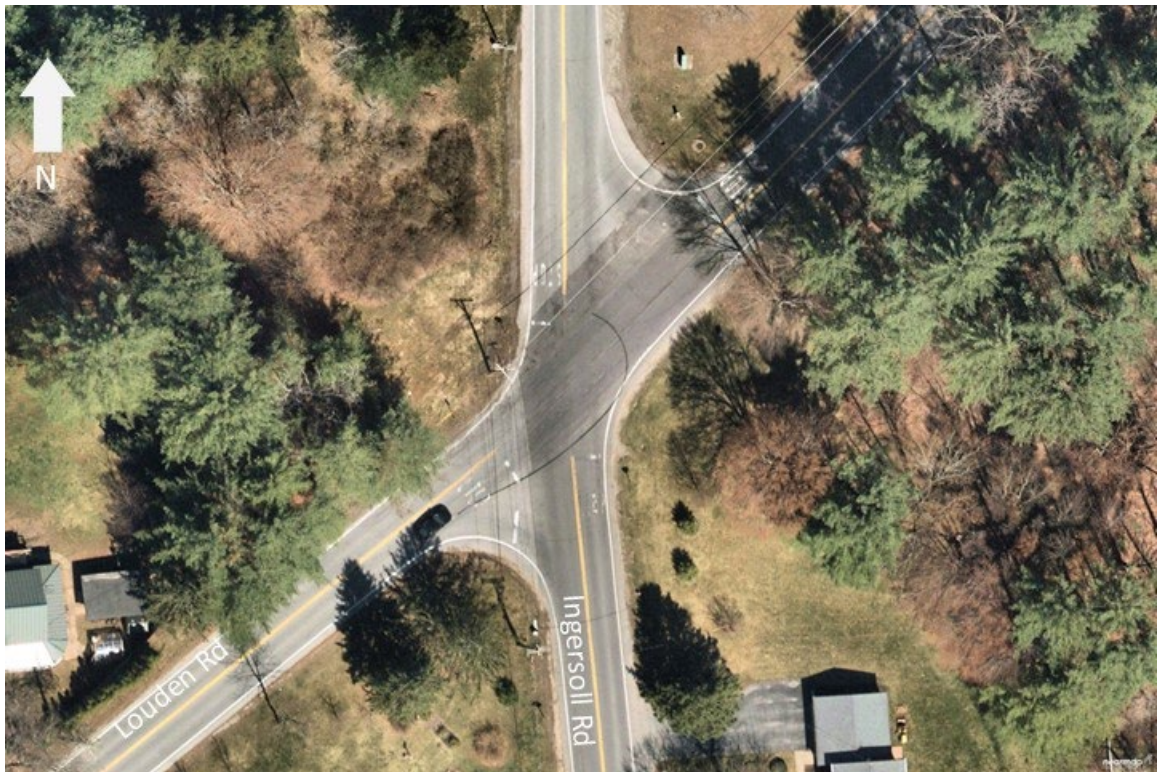
Louden Road at Ingersoll Road

The Loudon Road at Ingersoll Road intersection is a four-leg intersection operating under stop control on all four approaches. All four intersection approaches provide a single lane for shared travel movements. No pedestrian accommodations are provided at this intersection.

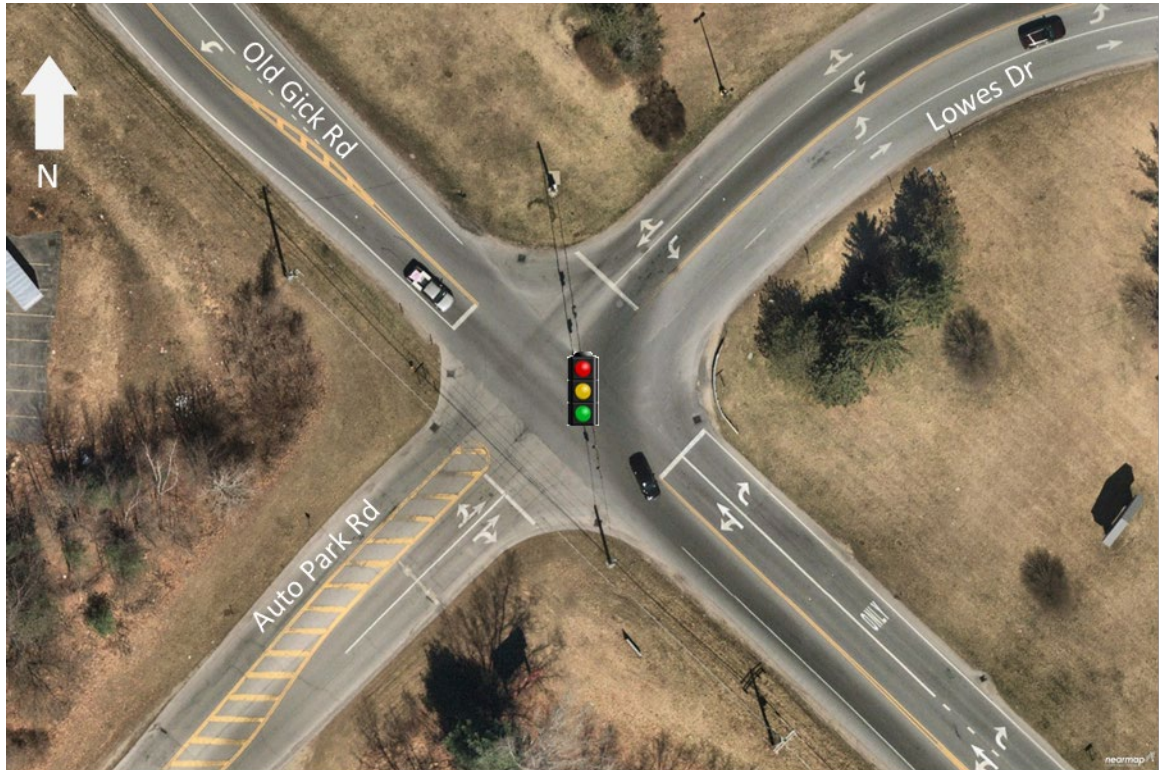
The Old Gick Road at Lowes Drive/Auto Park Road intersection is a four-leg intersection operating under signal control. The northbound Old Gick Road approach provides a shared left-turn/through lane and a right-turn lane. The southbound Old Gick Road approach provides a single lane for shared travel movements. The eastbound Auto Park Road approach provides a shared left-turn/through lane and a shared through/right-turn lane. The westbound Lowes Drive Approach provides a left-turn lane and a shared through/right-turn lane. No pedestrian accommodations are provided at this intersection.

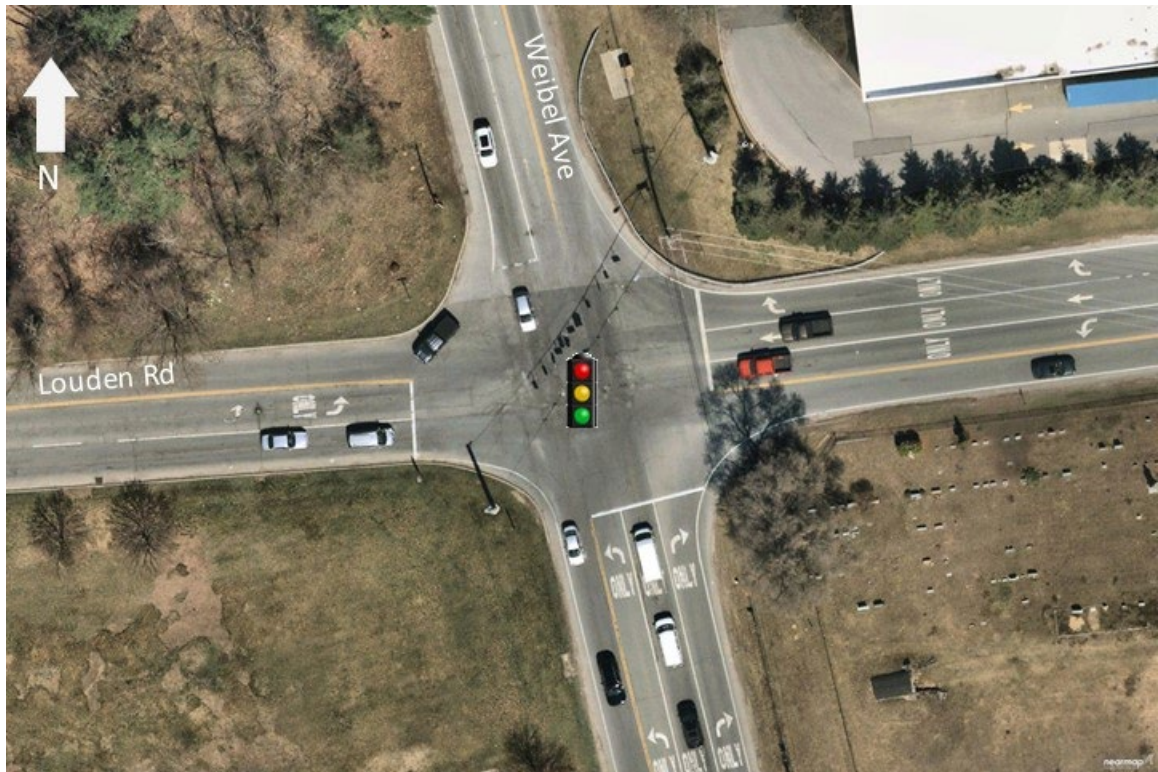
The Louden Road at Weibel Avenue intersection is a four-leg intersection operating under signal control. The eastbound Louden Road approach provides a left-turn lane and a shared through/right-turn lane. The westbound Louden Road and northbound Weibel Avenue approaches provide a left-turn lane, a through lane, and a right-turn lane. The southbound Weibel Avenue approach provides a left-turn lane and a shared through/right-turn lane. No pedestrian accommodations are provided at this intersection.

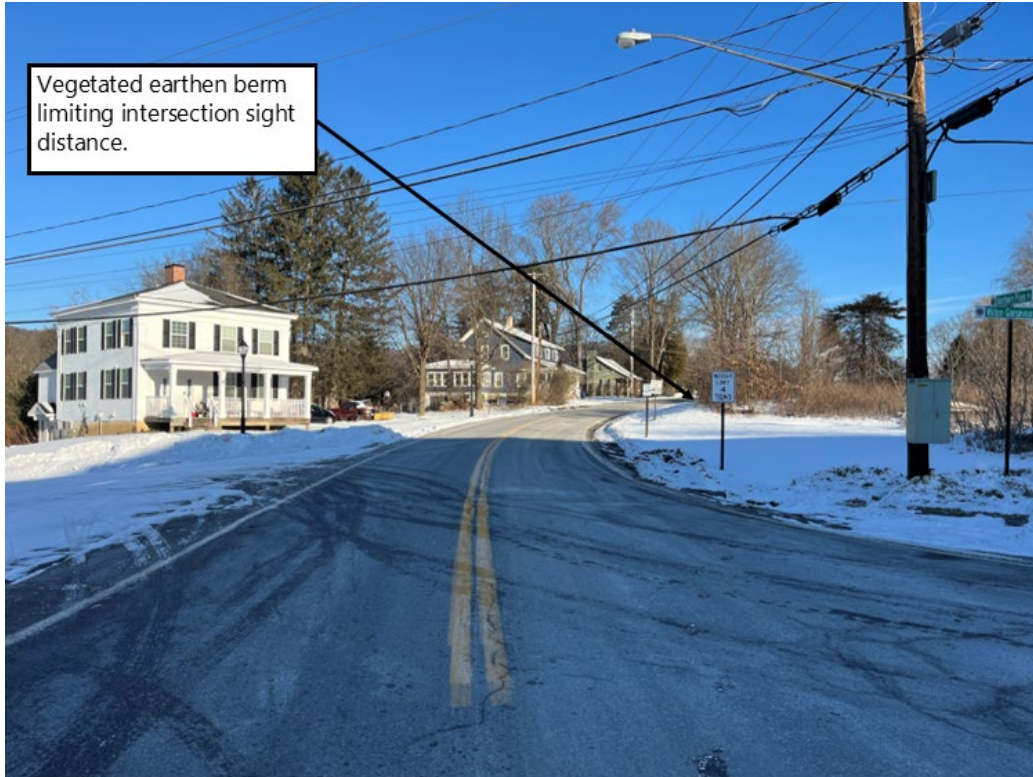
A review of Table 5 shows that the stopping sight distances meet the AASHTO guidelines for a 45-mph operating speed along Northern Pines Road. Table 6 shows that the intersection sight distances for passenger vehicles entering and exiting the Wilton Gansevoort Road approach meet the AASHTO guidelines for a 45-mph operating speed except for looking right for a left turn out. The sight line looking right for a left turn out is blocked by vegetation and an earthen berm, see photograph 2. It is recommended that the town coordinates with the landowner to clear vegetation to the extent possible and to regrade the earthen berm along the road frontage.

Photograph 2: Looking north on Northern Pines Road at Wilton Gansevoort Road.

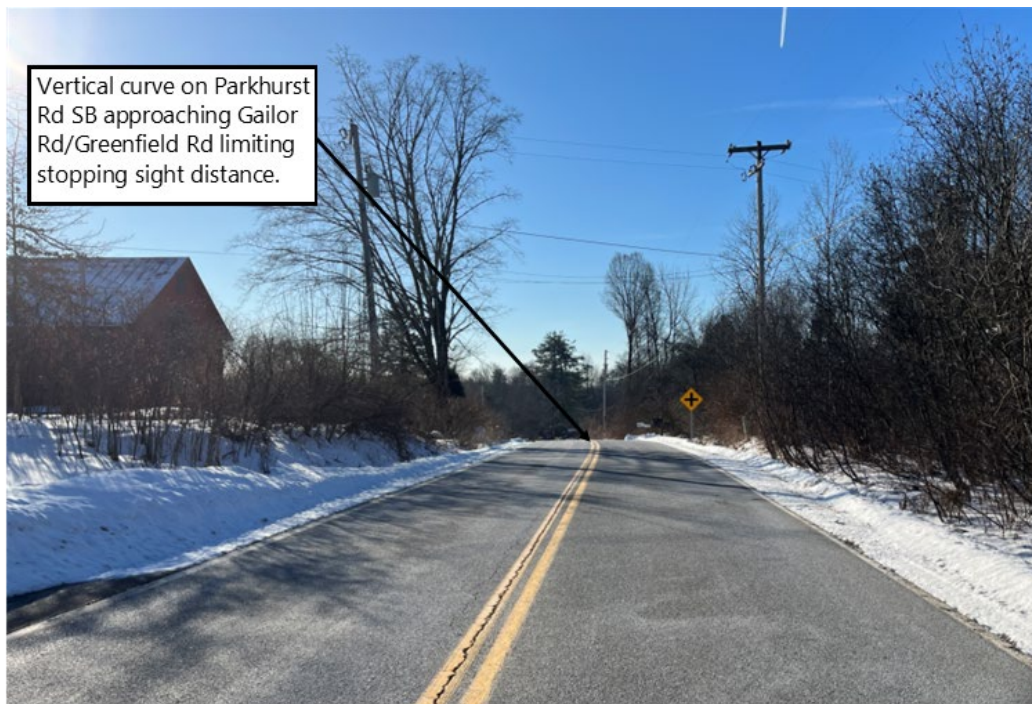
A review of Table 9 shows that the stopping sight distances meet the AASHTO guidelines for a 50-mph operating speed in the northbound direction along Parkhurst Road. The stopping sight distance for southbound vehicles is limited by the vertical curve in the roadway, see photograph 3.

Photograph 3: Looking south on Parkhurst Road to intersection with Gailor Road/Greenfield Road.

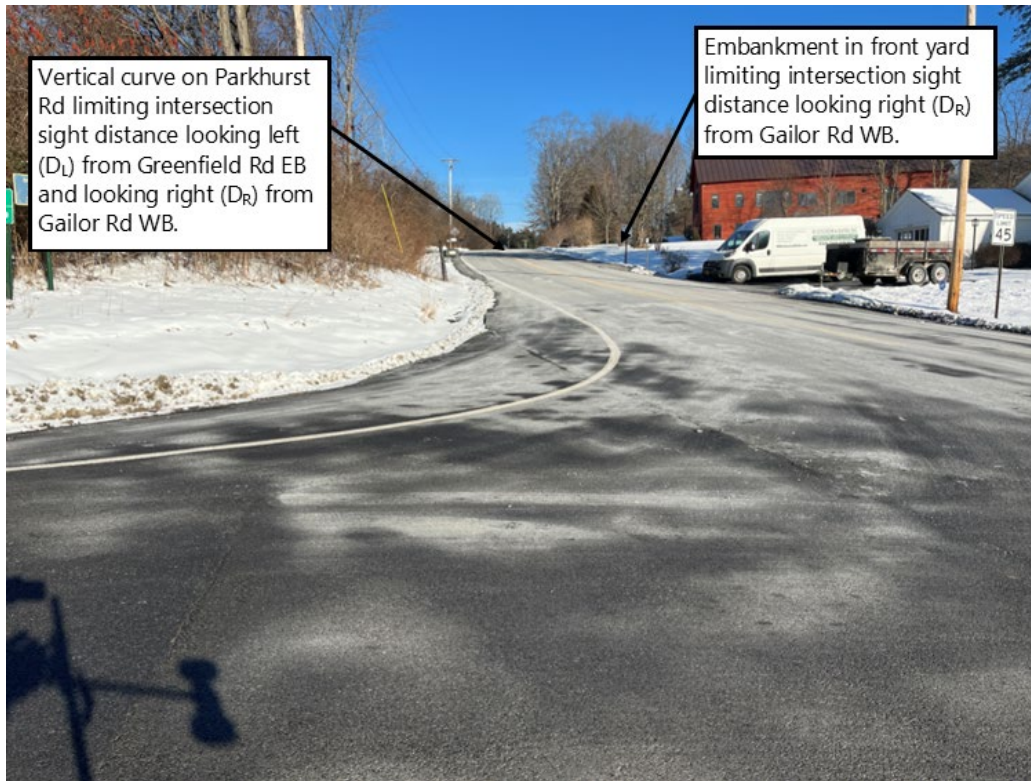
Table 10 shows that the sight distances looking north on both the eastbound and westbound approaches and the sight distance looking south on the westbound approach do not meet AASHTO guidelines for a 50-mph operating speed. The sight line looking left for a left and right turn out of the eastbound approach and the sight distance right out of the westbound approach are limited by

the vertical curve in the roadway and an existing embankment on a residential parcel, see photograph 4.

Photograph 4: Greenfield Road (eastbound) at Parkhurst Road looking north.

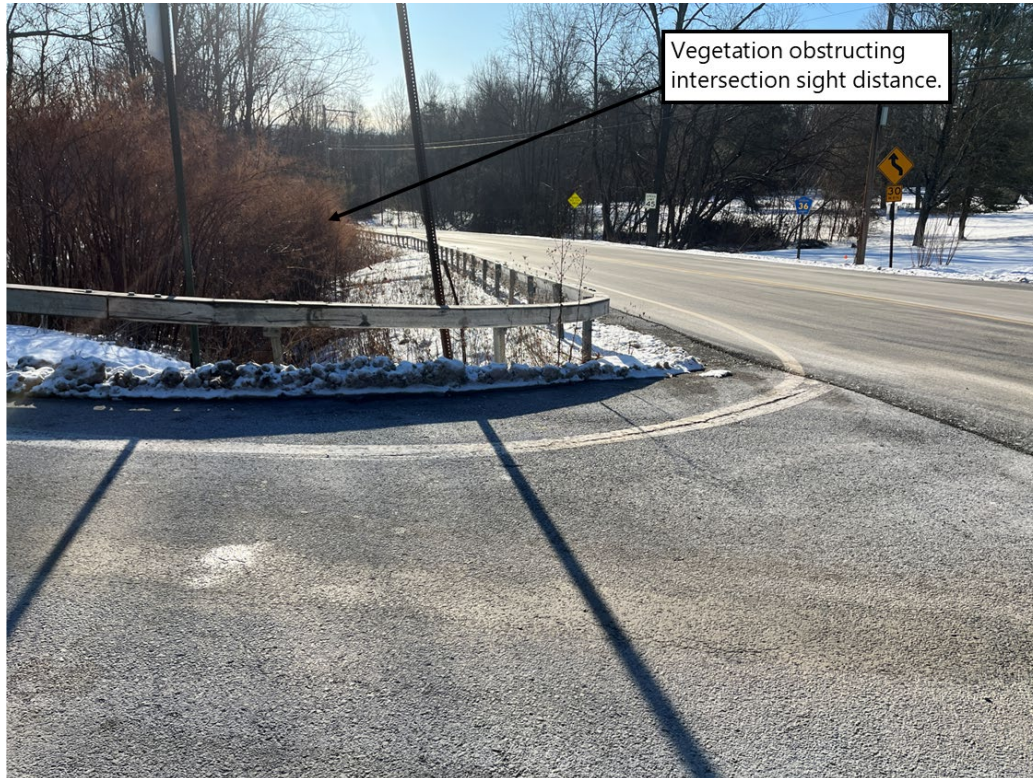
At the westbound approach, the sight line looking left for a left and right turn out is limited by vegetation along the east side of Parkhurst Road south of Gailor Road, see photograph 5. Review of Figure 2C-101 Guide for Intersection Warning Sign Use in the NYS Supplement to the MUTCD shows that the available sight distance is less than desirable and critically limited, as such, mitigation is needed. It is recommended that the town coordinate with the landowner along the east side of Parkhurst Road, south of Gailor Road to clear vegetation to the extents possible. There is an intersection warning sign on the southbound Parkhurst Road approach to the intersection with Gailor Road/Greenfield Road. No other mitigation is recommended.

Photograph 5: Looking left (DL) from Gailor Road westbound at Parkhurst Road

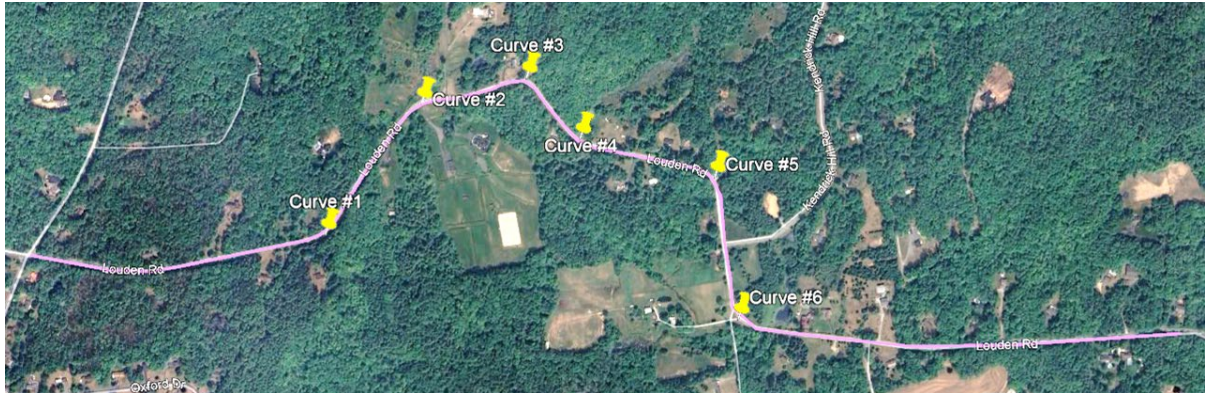
VHB completed five travel runs in each direction at the posted advisory speed for the six curves to measure the overturning force, by degrees, at each speed. The results of the field investigation can be seen on Tables 17 and 18. The tables show the maximum angle measured and the associated travel speed for each curve. If the maximum angle measured exceeds 10 degrees at a travel speed that is less than the posted advisory speed, then the posted advisory speed could be reduced. These locations are shown in **bold** in the tables.

Curve locations on Louden Road for ball banking evaluation

Based on NYS HDM guidelines, it is recommended that the advisory speed at Curve #6 be reduced to 15-mph in the eastbound direction. Based on NYS HDM guidelines, it is recommended that the advisory speed be reduced at Curve #2 to 20-mph and Curves #3 and #5 to 15-mph in the westbound direction.

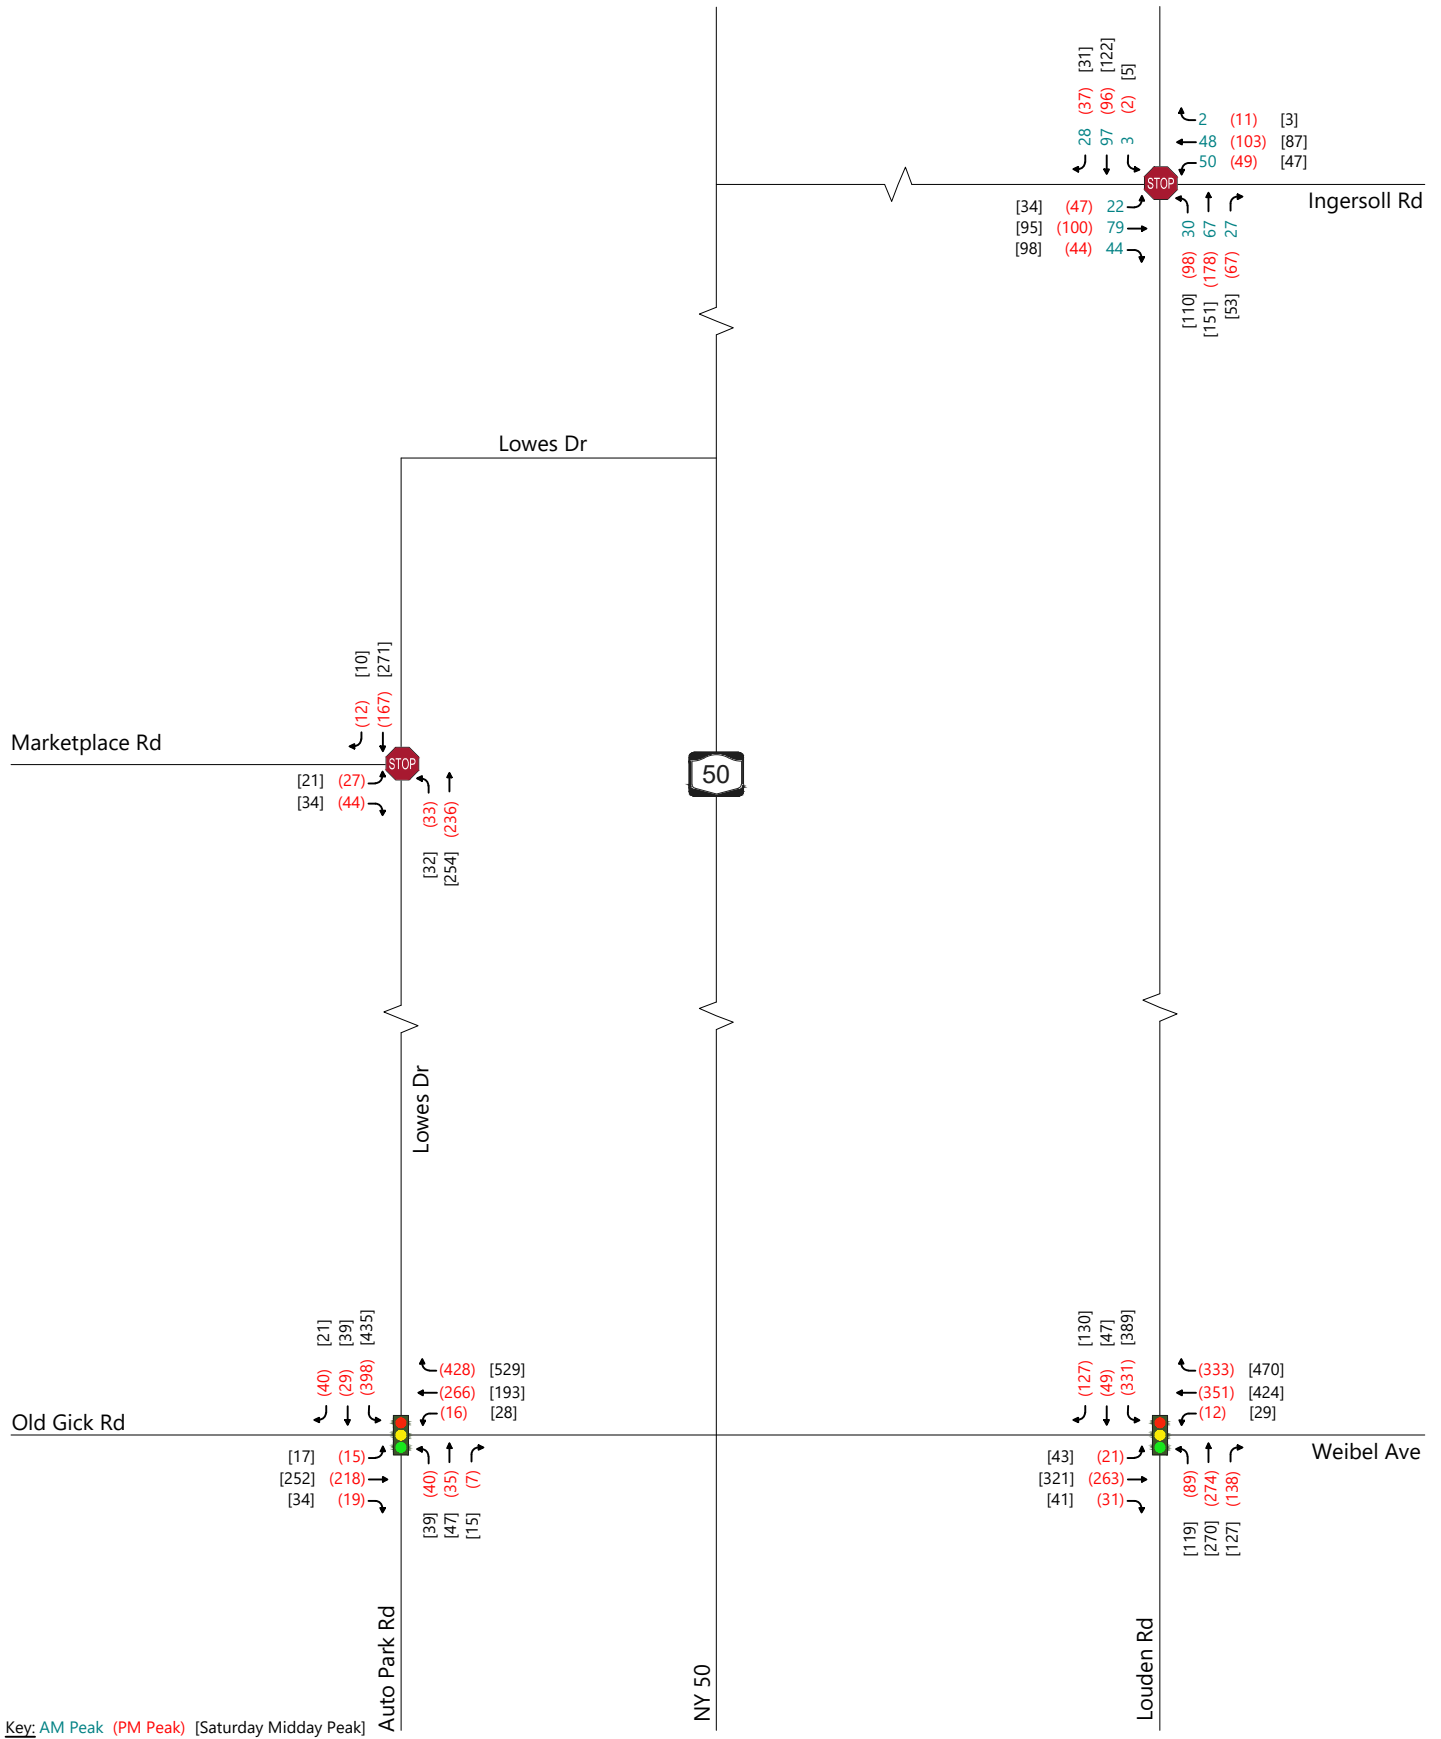
Figure 8

2035 Projected Traffic Volumes
 Commercial Center
 Traffic Planning Study
 Town of Wilton, NY
